Wooden Scout Cutter 113 Restoration

In May 2011 Cockle Bay Scout Group In Manukau Zone New Zealand were allocated Scout Cutter 113, as we had previously been borrowing a variety of Cutters to use with our Scouts and Venturers.

Cutter 113 was originally built by the Boat Building Class of the Industrial Department of Otahuhu College in 1964. 113 is a traditional clinker built Scout Cutter, being mainly constructed from Kauri.

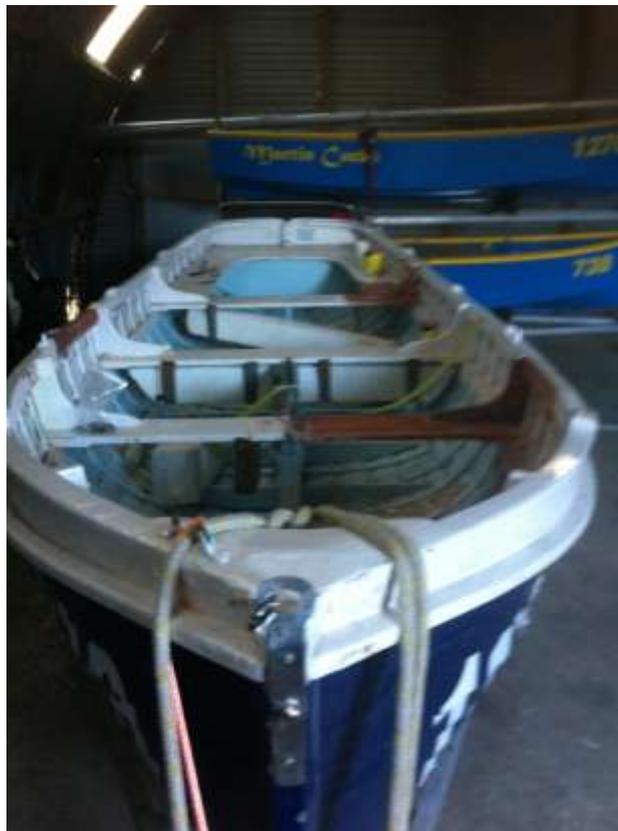
113 as we received her

Whilst at Kaiaua the boat had sustained some damage to the planking when it had been run aground on rocks, and there was a hole in the port forward area that had affected at least 2 planks.

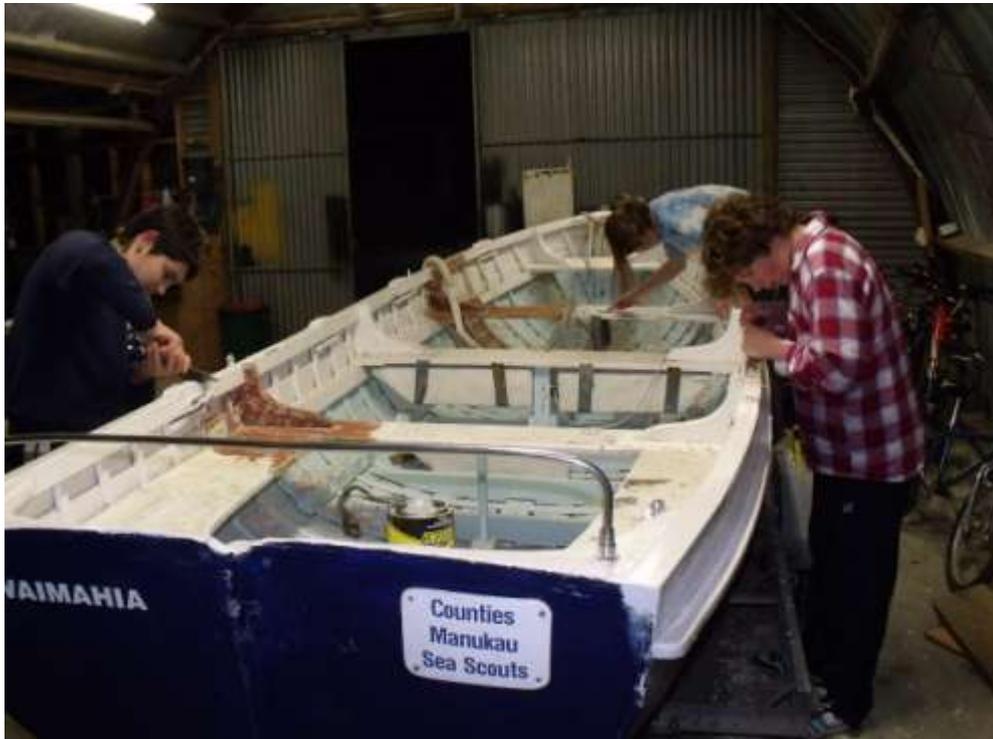
Venturers stripping paint.

done to it save an additional coat of paint. Because of the condition of the interior paintwork it was decided to completely strip the inside of the boat back to bare wood. Due to the complex nature of the inside of a clinker build boat, it was decided that the mainly large flat areas, seats, centre board casing, gunwales etc. would be stripped by hand using paint stripper and paint scrapers, but that we would seek professional advice as to how best to remove the paint from the interior planking, ribs etc. The best suggested solution to removing the interior paint was to have the complete inside soda blasted professionally. After the Venturer unit and Howick rover Crew had put in many hours stripping and scraping the large flat areas of the boat, Ecoblast Ltd were engaged to soda blast the boat's interior. The soda blasting took some 5 hours, and at the end of the exercise the majority of the paint had been removed to reveal the bare wood interior. Because even the soda blasting would have caused erosion to the wood of the boat had it been too prolonged, areas of old paint remained around the intersections of the ribs with the keel, and in certain other areas, so many more hours of scraping and sanding were required before the inside of the boat was ready for painting.

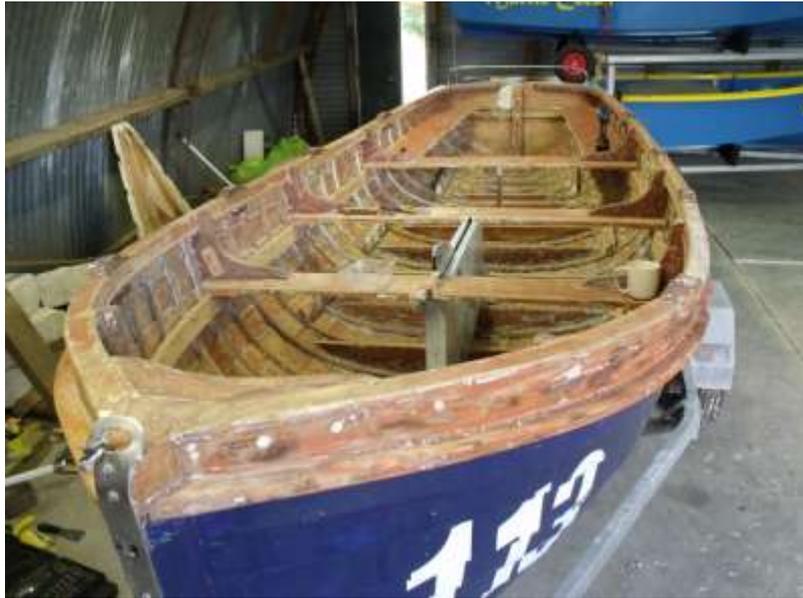
Interior paint removed.

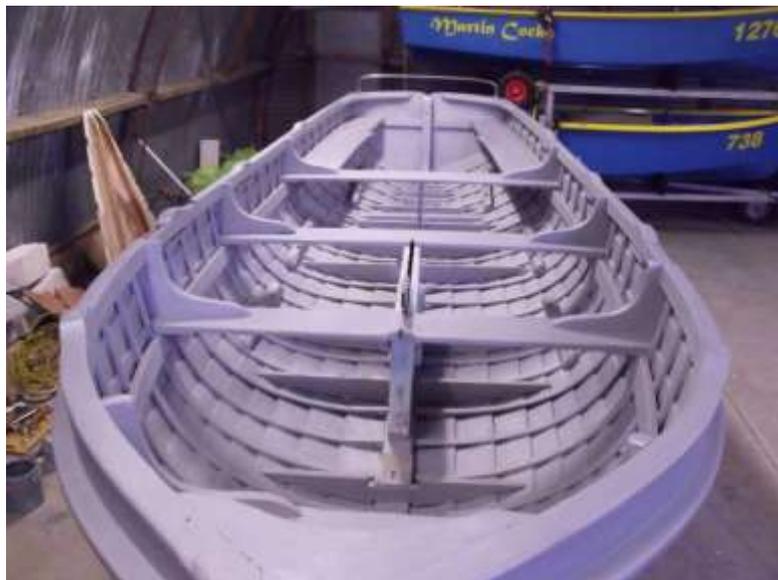
Inside primer applied

With the inside of the hull ready for painting we then applied 1 coat of International Yacht primer, 2 coats of International Prekote undercoat and 4 coats of International Toplac enamel topcoat. Once the interior had been repainted the structural repairs were then carried out.

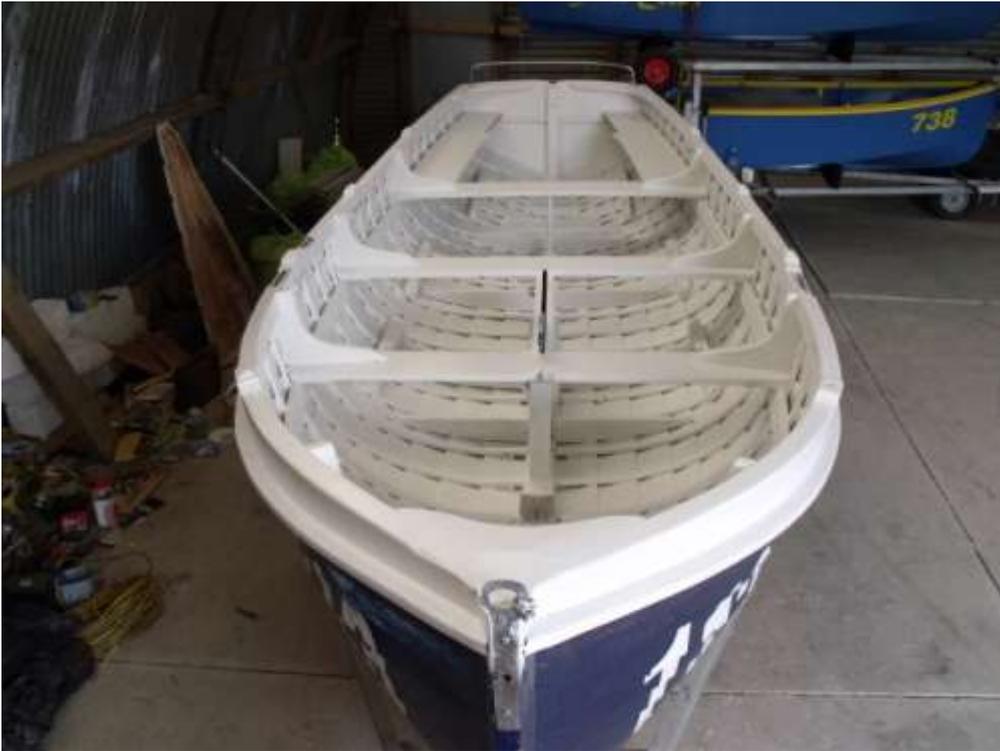
Undercoat complete

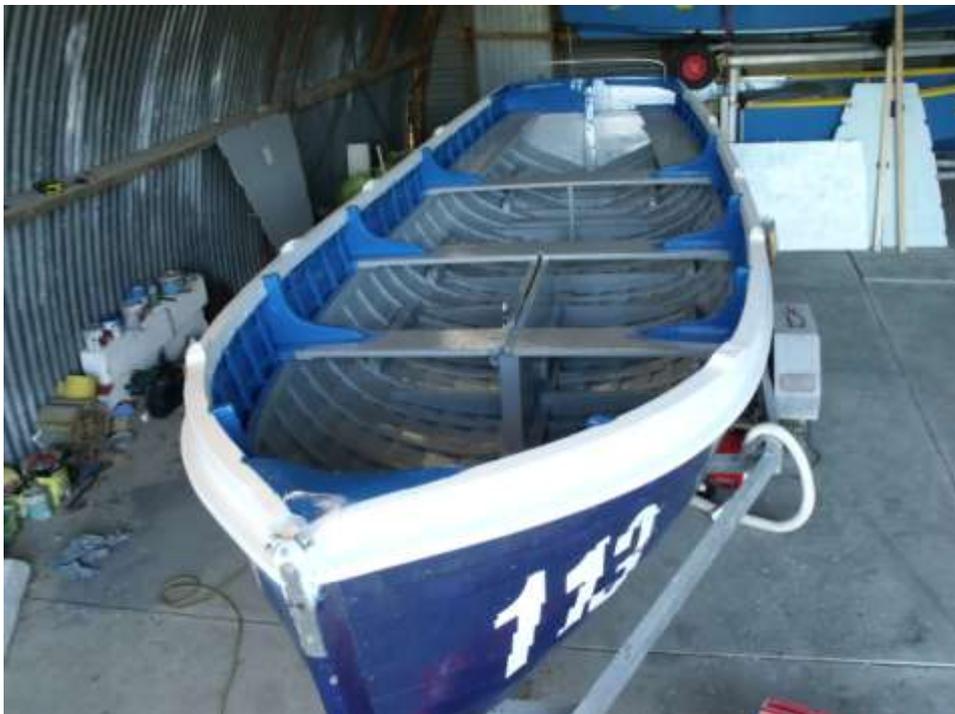
Inside painting finished

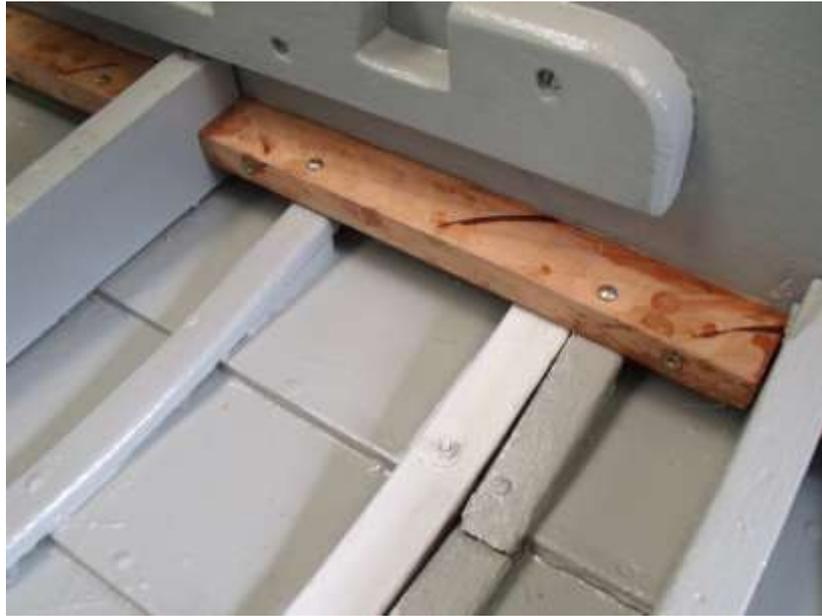
Internal structural repairs

All the broken or cracked ribs were splinted, with new rib sections being made and then fixed into the hull next to the broken or cracked old ones, with the originals being left in place. Instead of using the traditional method of fixing the new ribs into the hull with copper rivets and roves, they were fixed using stainless steel nuts and bolts which were sealed with epoxy resin. Where the intermediate ribs had come away from the centre board casing, a new piece of wood was screwed into the centre board casing running longitudinally down the length of the centre board casing on each side, on top of the ribs, and then screws were put right through the new timber and into the ribs to ensure the ribs were once again securely attached to the centre board casing. To increase buoyancy a new foredeck was constructed in place of the original forward thwart, and this was filled with 1.5l fizzy drink bottles.

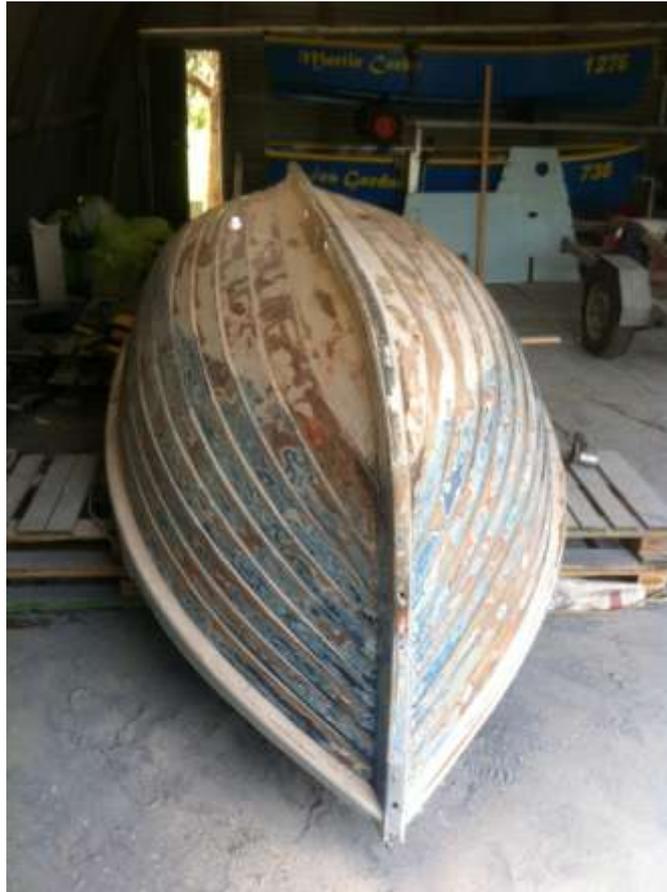
Outside sanded ready for painting.

With the inside of the boat repainted it was time to turn our attention to the exterior of the hull. The boat was turned over and the old paint was sanded back until it gave a smooth and even surface for repainting. Because the outside of the hull was not taken back to bare wood, priming was not necessary, so the outside was painted with 3 coats of International Prekote undercoat and 3 coats of International Toplac enamel topcoat, except for the gunwales, which because we elected to paint them yellow, required 5 coats!

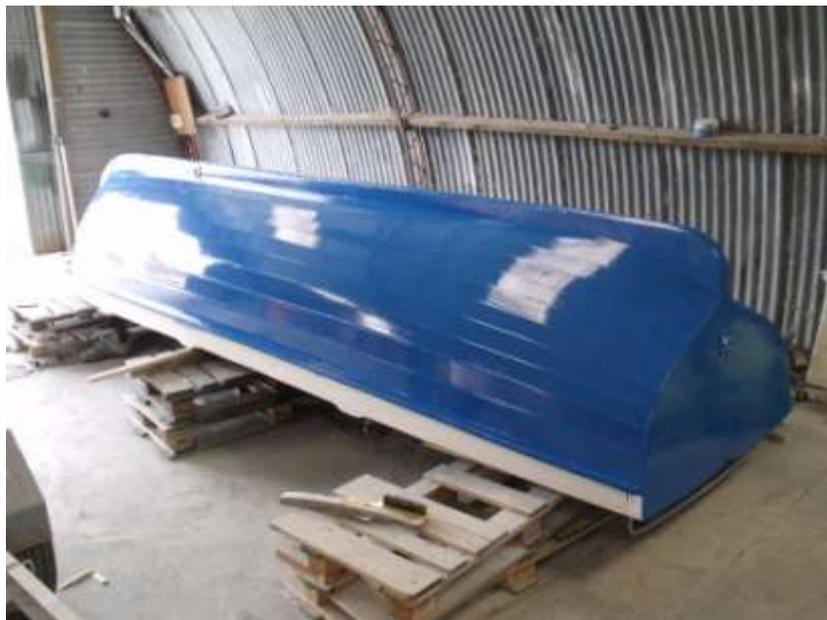
Exterior topcoat complete.

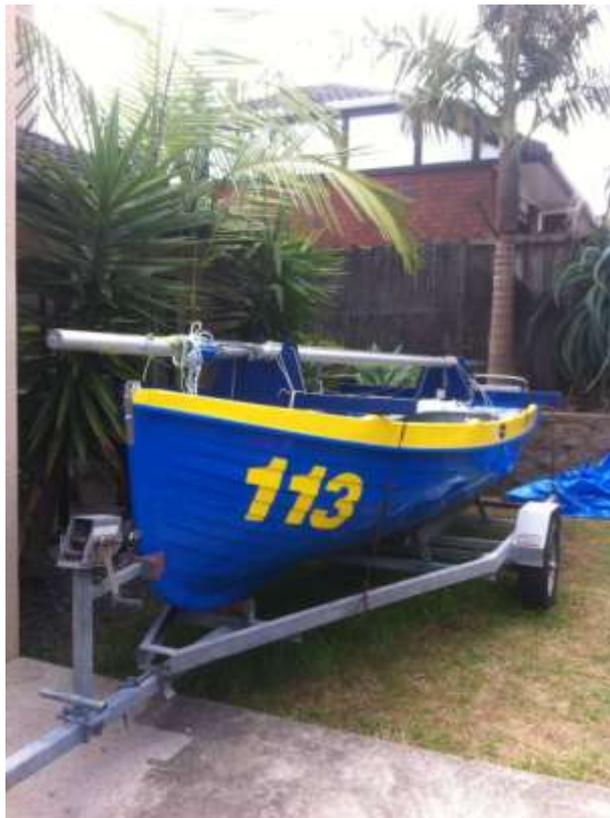
The completed job.

Once the exterior painting was finished the boat was turned over and put back on the trailer. An assessment of the boat's fittings resulted in most of the old ones being discarded in favour of new replacements, this included making a complete new rudder mount. All the standing and running rigging was checked and all the running rigging replaced, along with the replacement of the anchor, chain and warp and both bow and stern painters. New floor boards were made to fit either side of the centre board casing as these were missing from the boat originally.

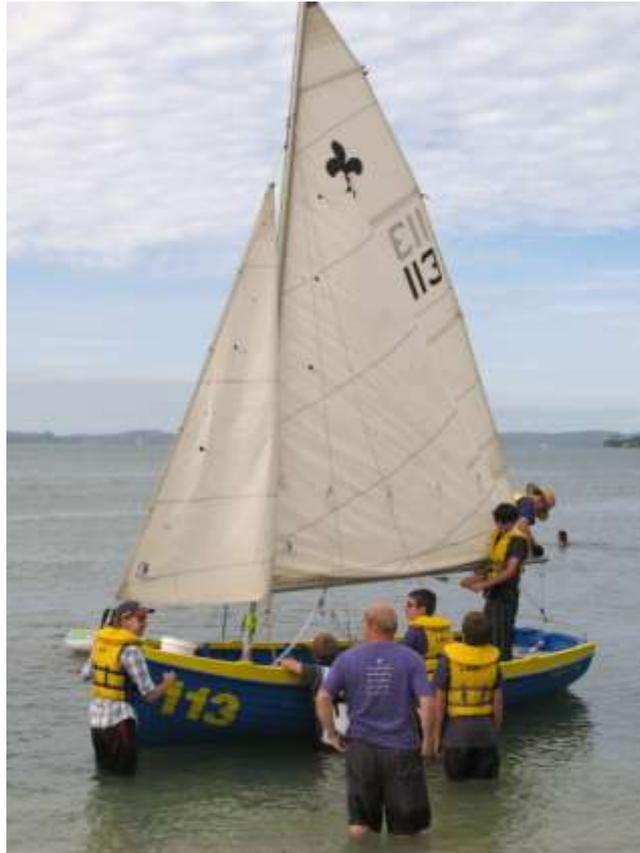
On 21st January 2012 113 was re-launched in Cockle Bay for her initial sea trials. The trials were conducted with the original sails, which we knew were tired and had no battens. The sea trials were a success, and

although the boat had been out of the water for some 3 years, the hull did not leak too badly. Following the sea trials more buoyancy was added under the floors in the shape of 330ml juice bottles. 2 months after the sea trials we were fortunate enough to be able to procure a brand new set of sails.

Sea Trials.
